EUROPAFILTER ASSEMBLED ON TRANSMISSION BOX

**Customer:**  
Drønen Havfiske AS,  
**Chief Engineer:** Reidar Vassnes

**Application:**  
Transmission gear drive box

Vessel: "MS Storeknut"

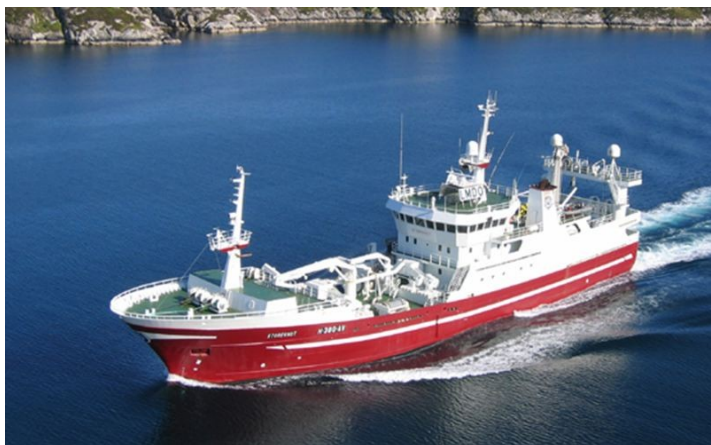
**History:**  
Transmission gear drive box was assembled onboard "MS Storeknut" in 1996. Europafilter was assembled in January 2006. No oil changes since the EF assembly was carried out. The oil has 34000 hours of operation on the gear with the EF system in service. Total operation service hours of the gear drive box are 50500 h. The gearbox has operated approximately 15000h before the EF system assembly took place. It is common that machinery components are very clean when the lubricant system is treated with the EF system.

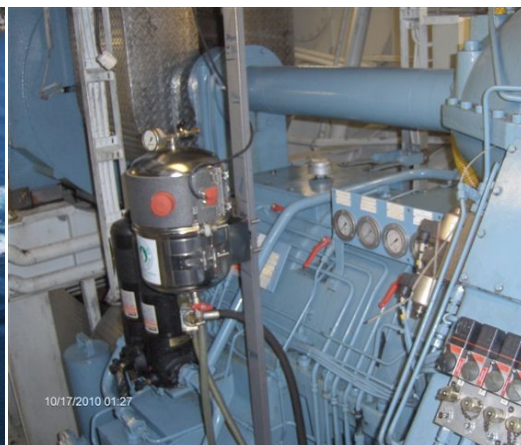
Scana Volda, 2000Kva, 1800 Kw,  
Lubricant: Mobilgear XP 600 100

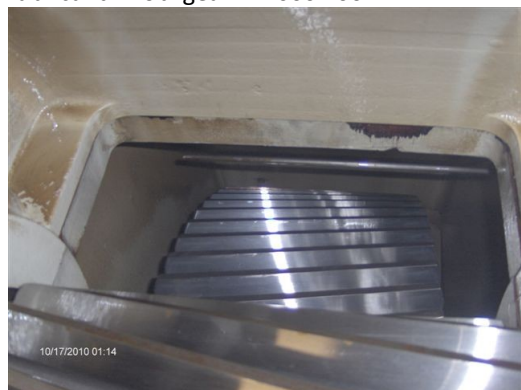
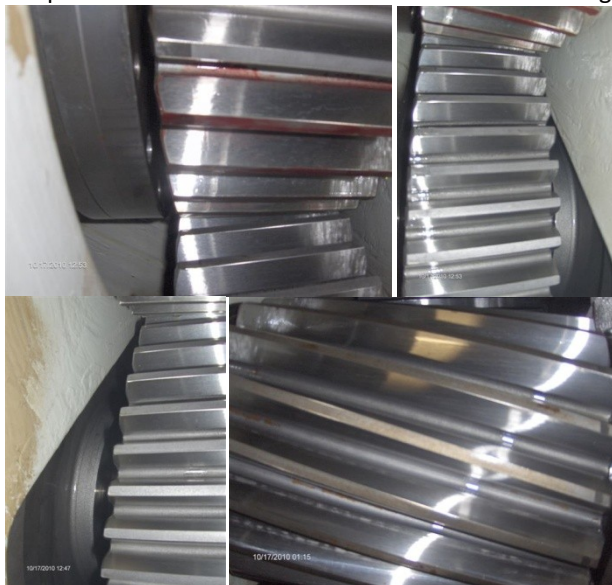
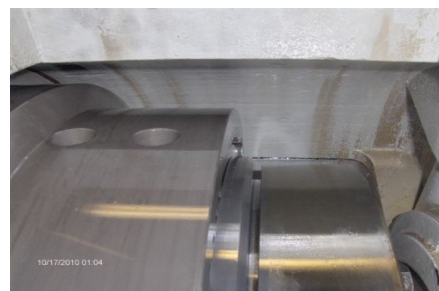
The pictures show unusual cleanliness levels inside the gear drive box.
